FIRMWARE UPGRADE ON AN RX8200

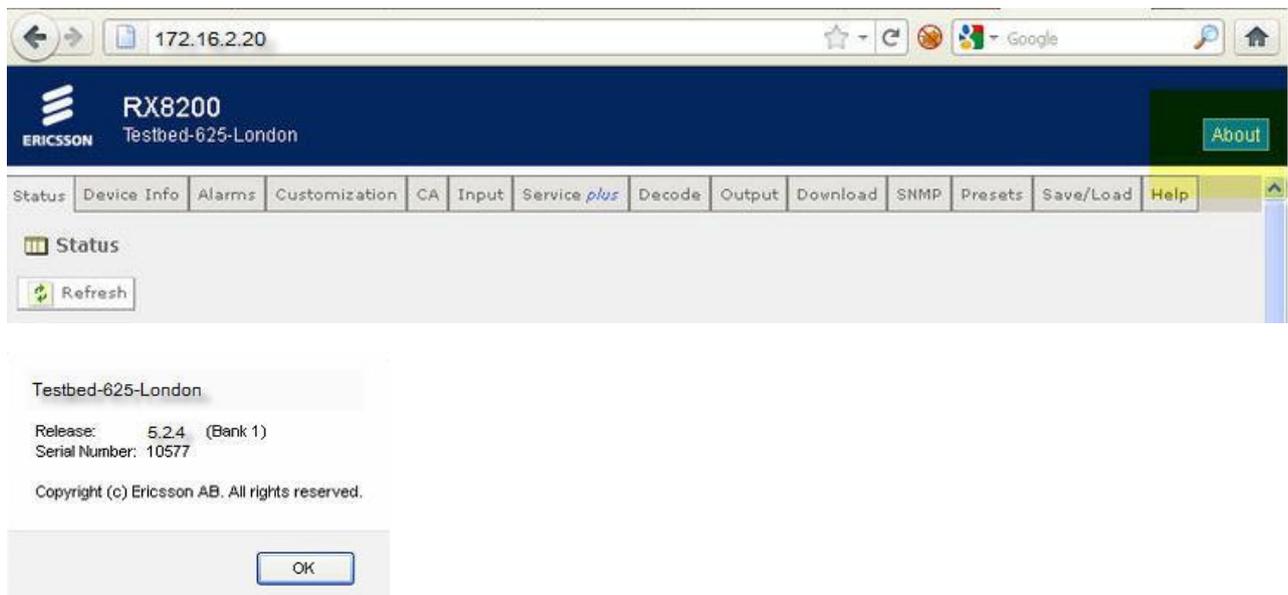
1. Select the **About** tab on the top right hand side of the page and note the software Flash Bank that is currently in operation. You will see either (**Bank 1**) or (**Bank 0**).

Figure 1. Checking Active Flash Bank.

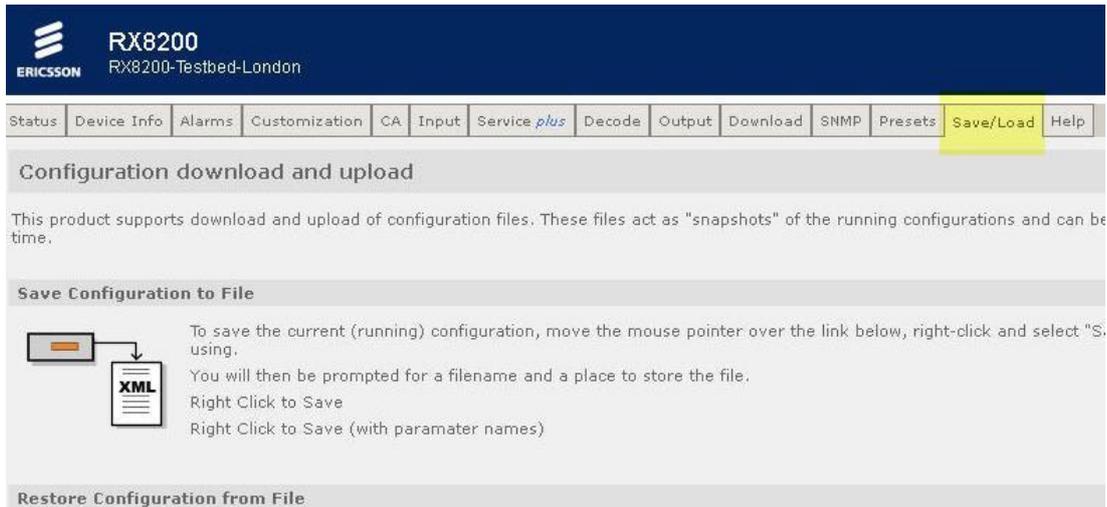
2. Navigate to the **Save/Load** tab and scroll to the bottom of the page.

Figure 2. RX8200 Save/Load Tab.

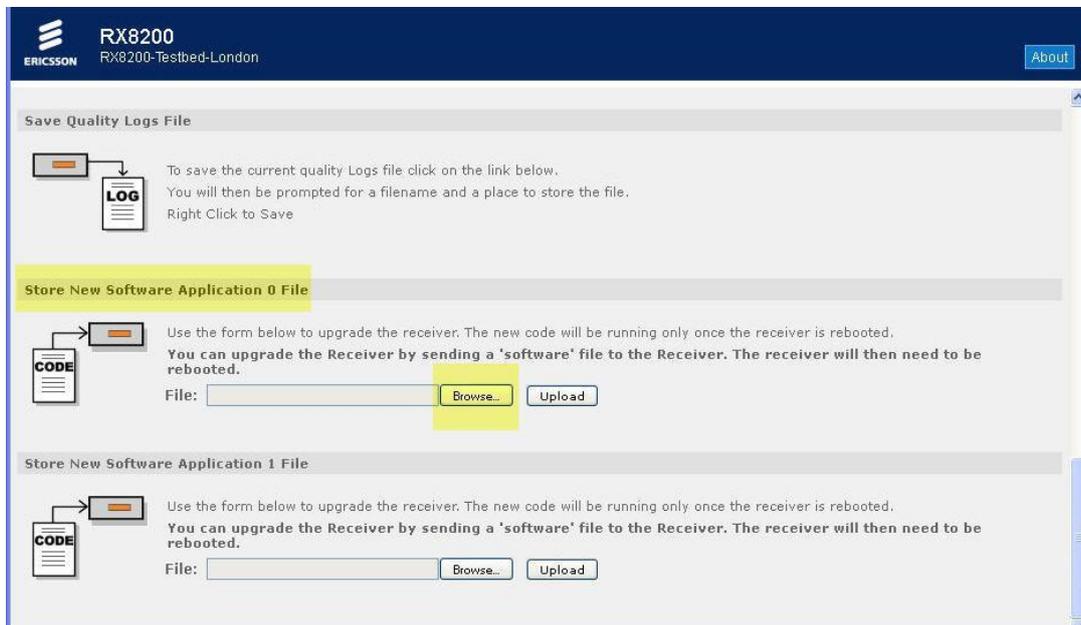
3. In the example above, as the 'active' Flash Bank is 1 we want to install the upgraded firmware into the other Flash Bank (i.e. Bank 0) Scroll down this page until you locate the **Store New Software Application 0 File**. This will present us with the access route to Bank 0.

Figure 3. RX8200 Bank 0

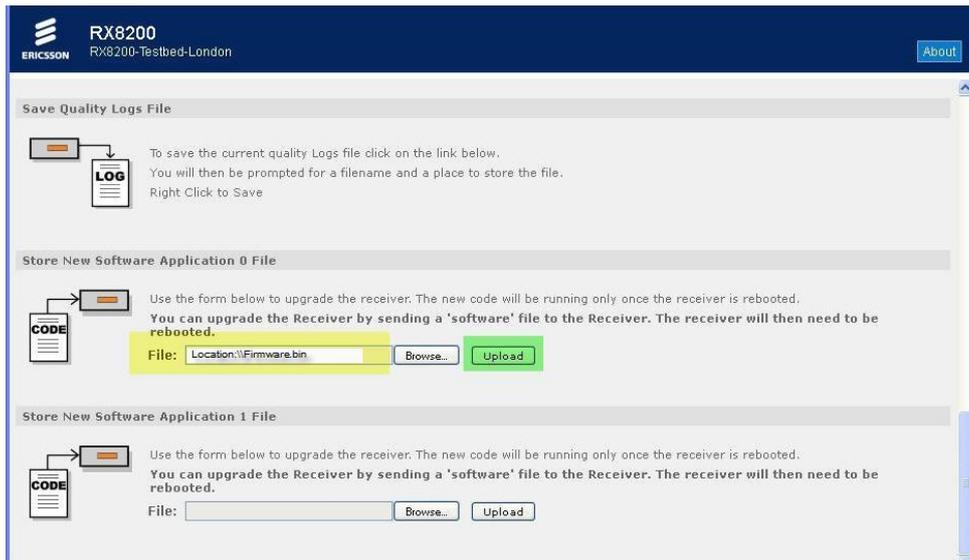
4. Click on the Browser button and locate the firmware upgrade **vx.x.x.bin** file where ever it's stored on the connected WNE Server or on a USB memory key.

Figure 4. RX8200 Bank 0 Firmware Upload.

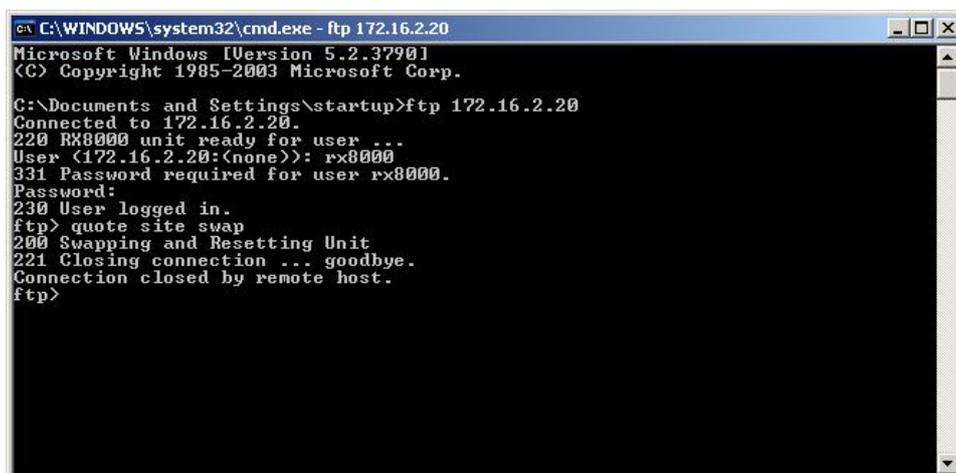
1. Open a DOS window within Windows and type ftp 172.16.2.20 (i.e. the Mgmt Address of CONTROL 2).
2. The username and password for accessing the RX unit is *rx8000/rx8000*.
3. Once you are successfully into the receiver, the command to switch between flash banks is **quote site swap**.
4. Once you hit return after typing this command the receiver will automatically reboot into the alternative Flash Bank.

Figure 5. RX8200 FTP Access
